TRANSMISSION THERMAL MAPPING (CH-47C
FORWARD ROTOR TRANSMISSION)

Boeing Vertol Company

3. REPORT TITLE TRANSMISSION THERMAL MAPPING (CH-47C FORWARD ROTOR TRANSMISSION)		
4. DESCRIPTIVE NOTES (Type of report and inclusive dates) Test and Demonstration Report (Final Report)

5. AUTHOR(S) (First name, middle initial, last name) Rocco C. Tocci A. J. Lemanski Nelson J. Ayoub		
6. REPORT DATE May 1973	7a. TOTAL NO. OF PAGES 167	7b. NO. OF REFS
8a. CONTRACT OR GRANT NO. DAAJ02-72-C-0075	8a. ORIGINATOR'S REPORT NUMBER(S) USAAMRDL Technical Report 73-24

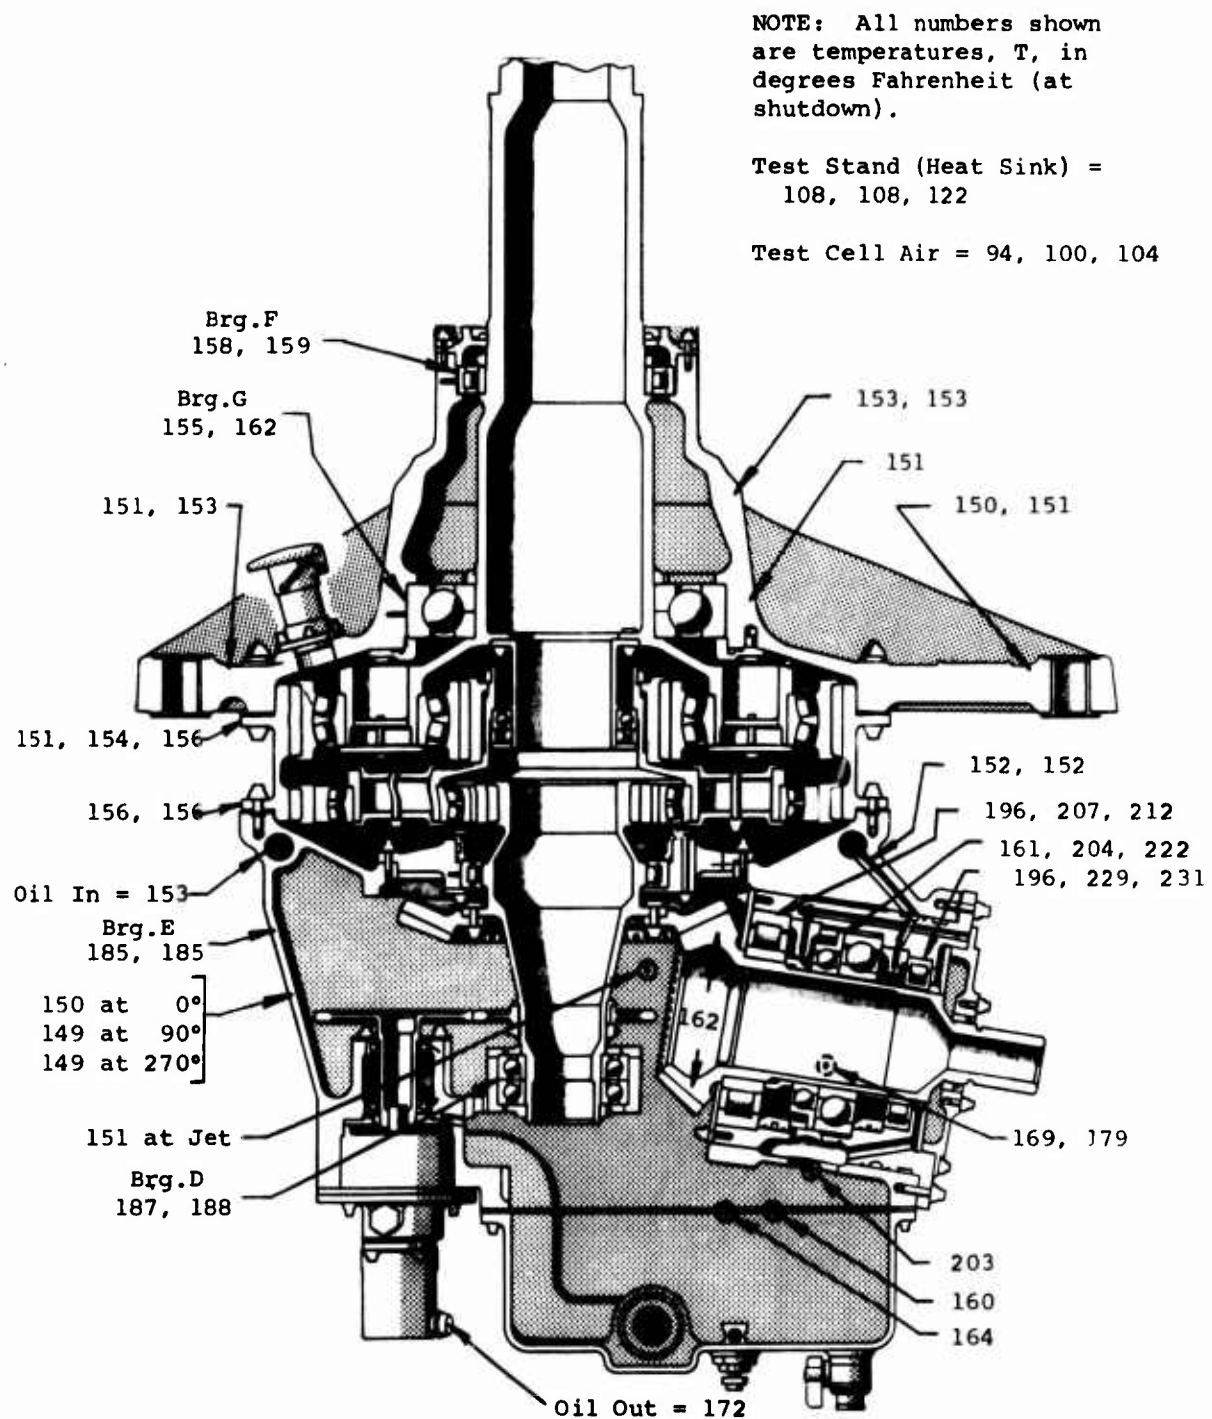
Figure 45. Thermal Map of Test 1 at 75 Percent Torque.

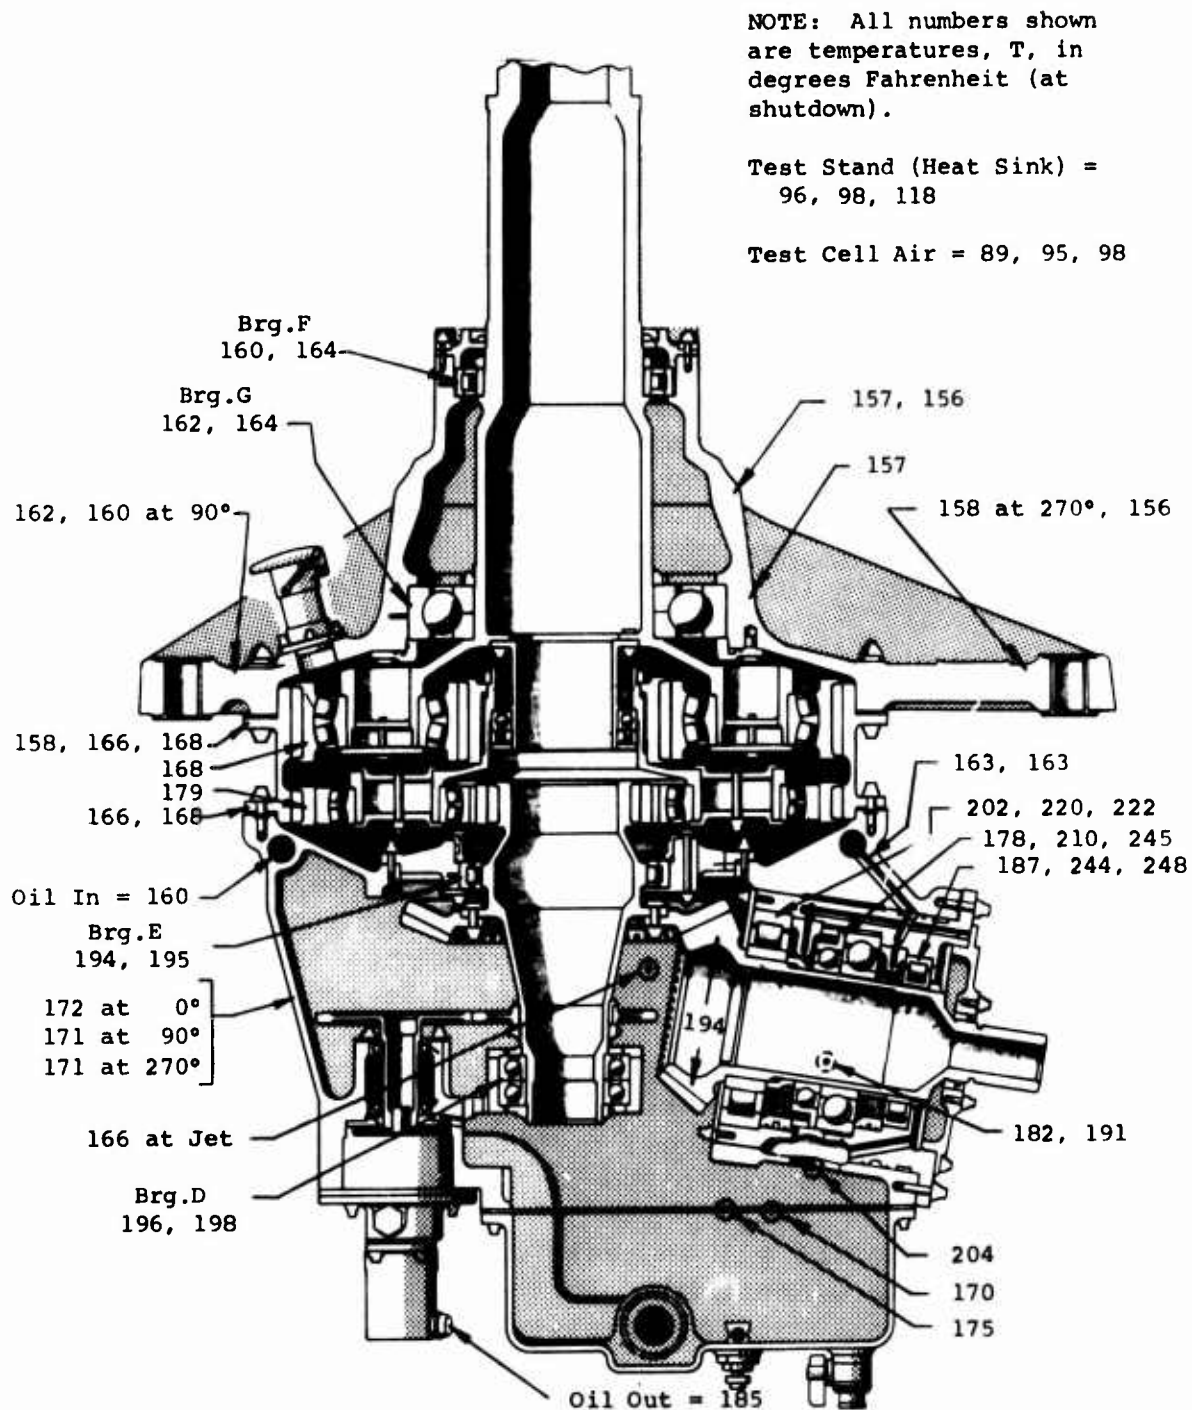
Figure 46. Thermal Map of Test 1 at 100 Percent Torque.

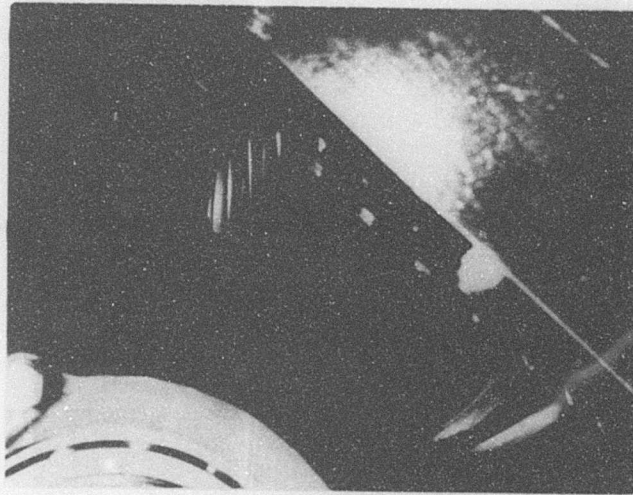
Figure 47. Spiral Bevel Pinion Teeth After Test 1.

Figures 47, 48, and 49 are photographs of the transmission components inspected at the end of all segments of test 1. Figure 47 shows the condition of the spiral bevel pinion. Figure 48 shows the condition of the spiral bevel pinion and the underside of the lower transmission case and spiral bevel gear shaft (with thermocouple leads). Figure 49 shows the condition of the sump, screen, and thermocouple. The first- and second-stage planetary components were visually inspected in the test stand, but no photographs were taken.

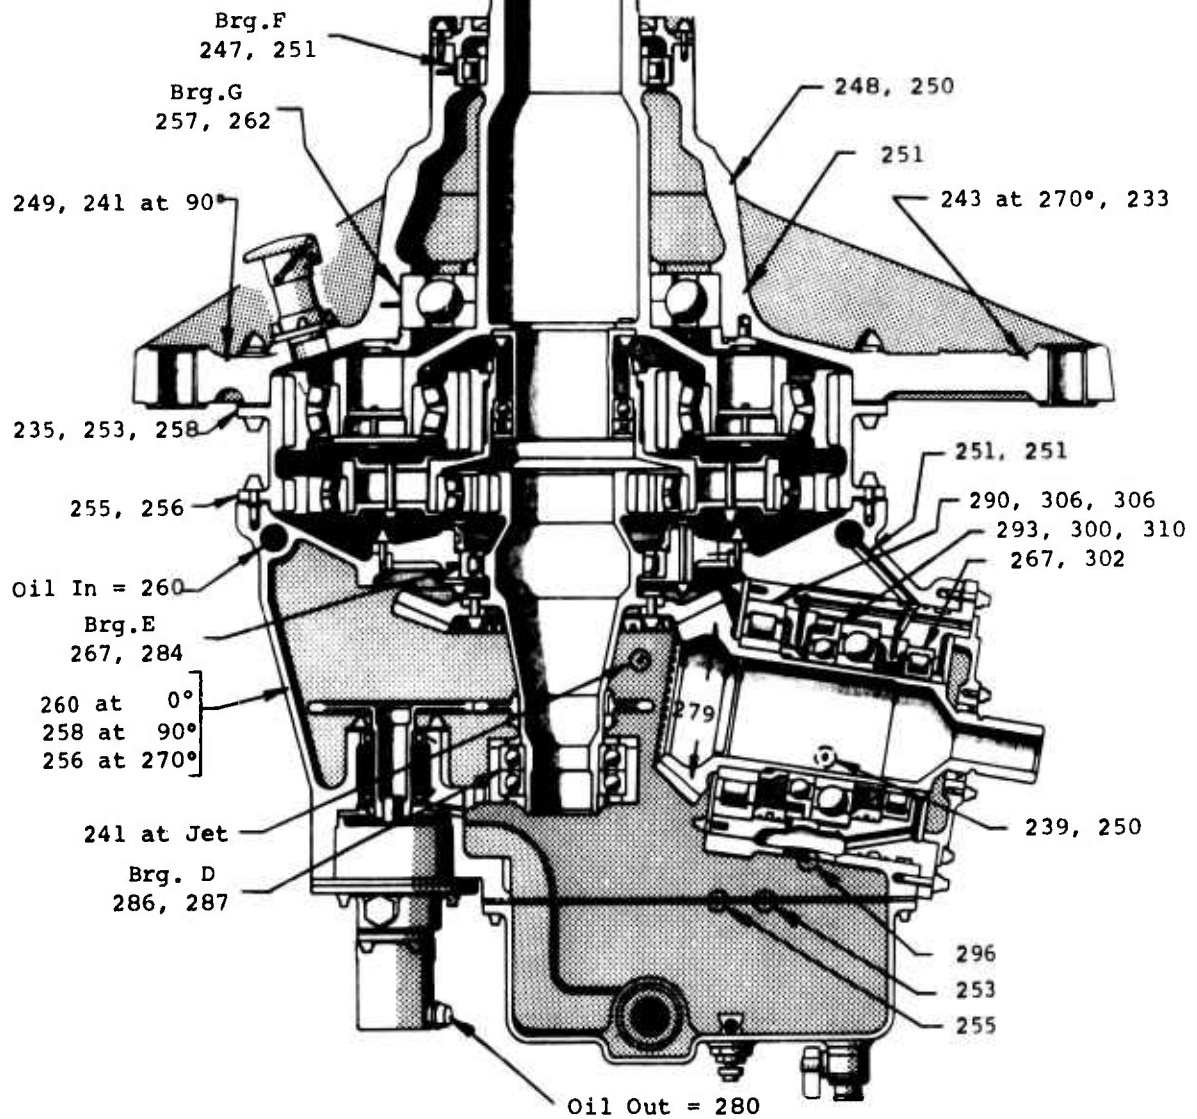
Figure 50. Thermal Map of Test 2 at 50 Percent Torque.

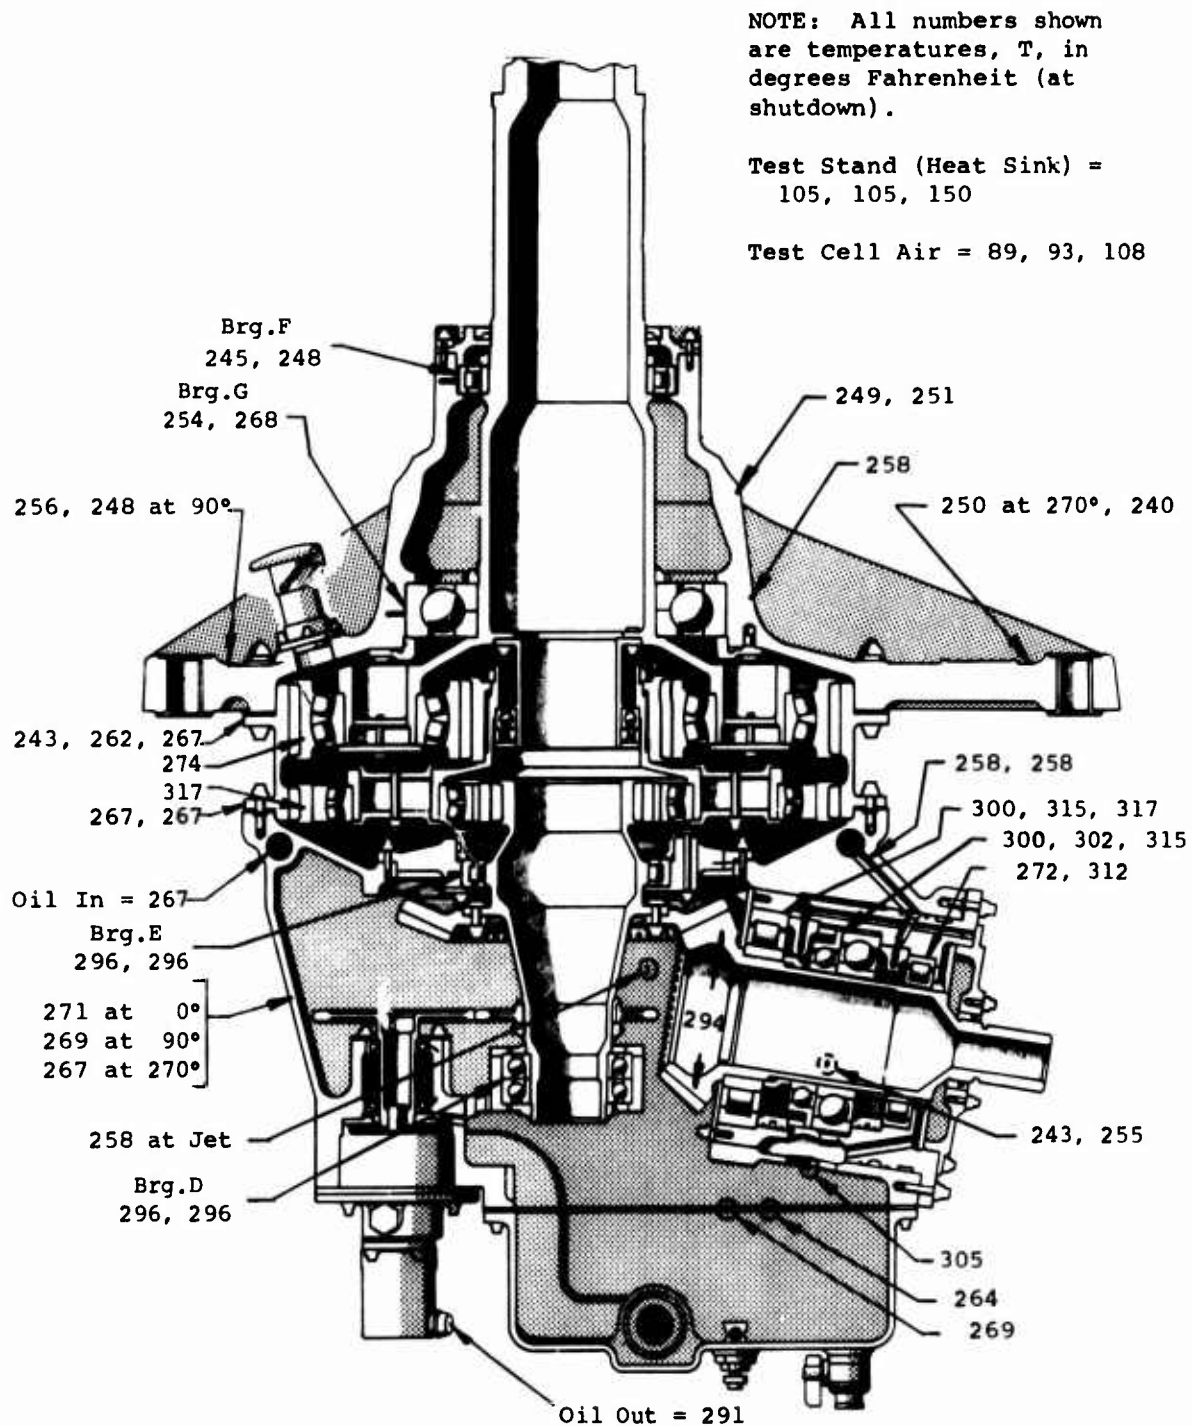
Figure 51. Thermal Map of Test 2 at 75 Percent Torque.

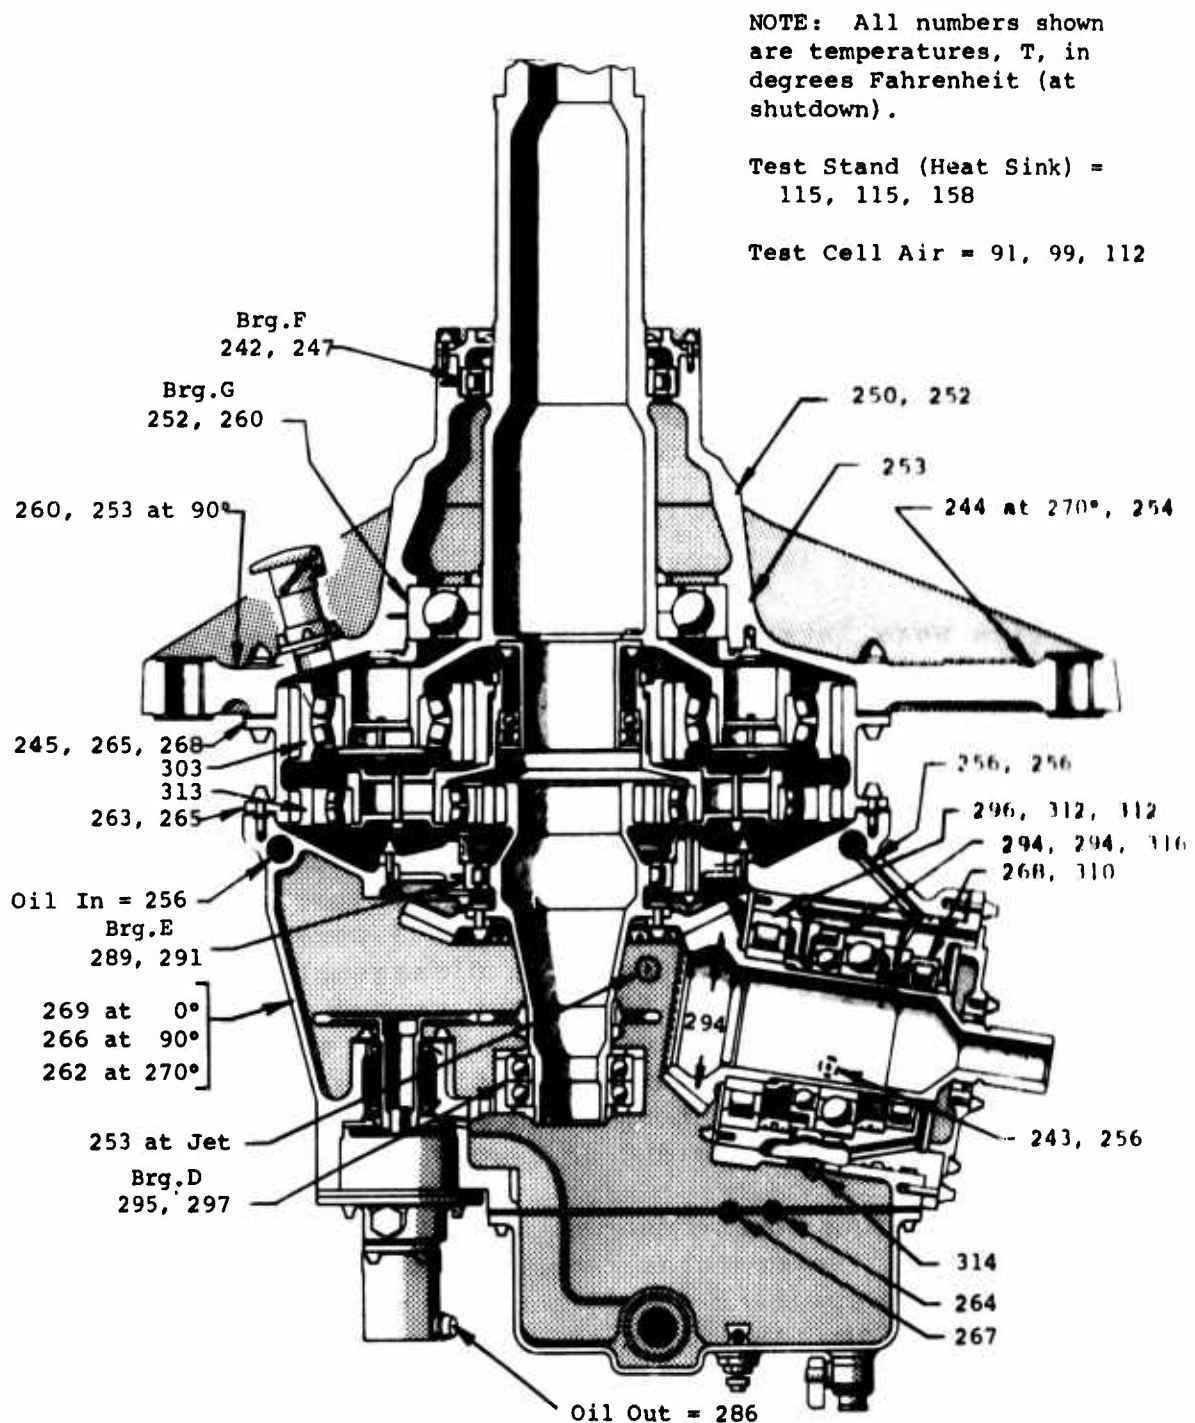
Figure 52. Thermal Map of Test 2 at 100 Percent Torque.

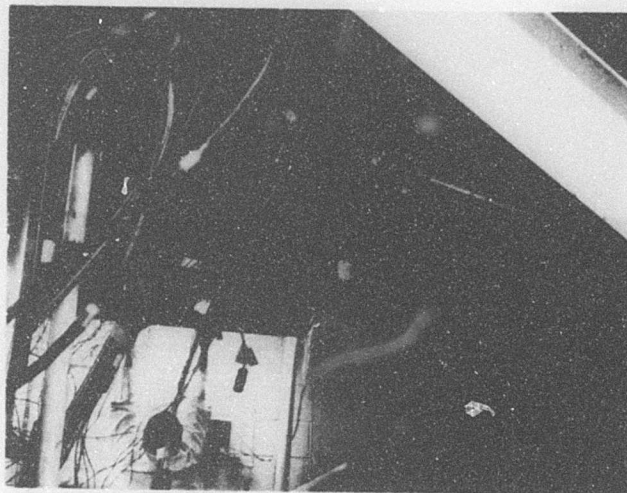
Figure 53. Specimen Transmission Disassembled for Inspection in Test Stand (End of Test 2).

Figures 53, 54, and 55 are photographs of the transmission components inspected at the end of all segments of test 2. Figure 53 shows the disassembly state of the specimen transmission in the test stand. Figure 54 shows the acceptable condition of the spiral bevel pinion. Figure 55 shows the condition of the sump, screen, and thermocouple. First- and second-stage planetary components were visually inspected in the test stand, but no photographs were taken.

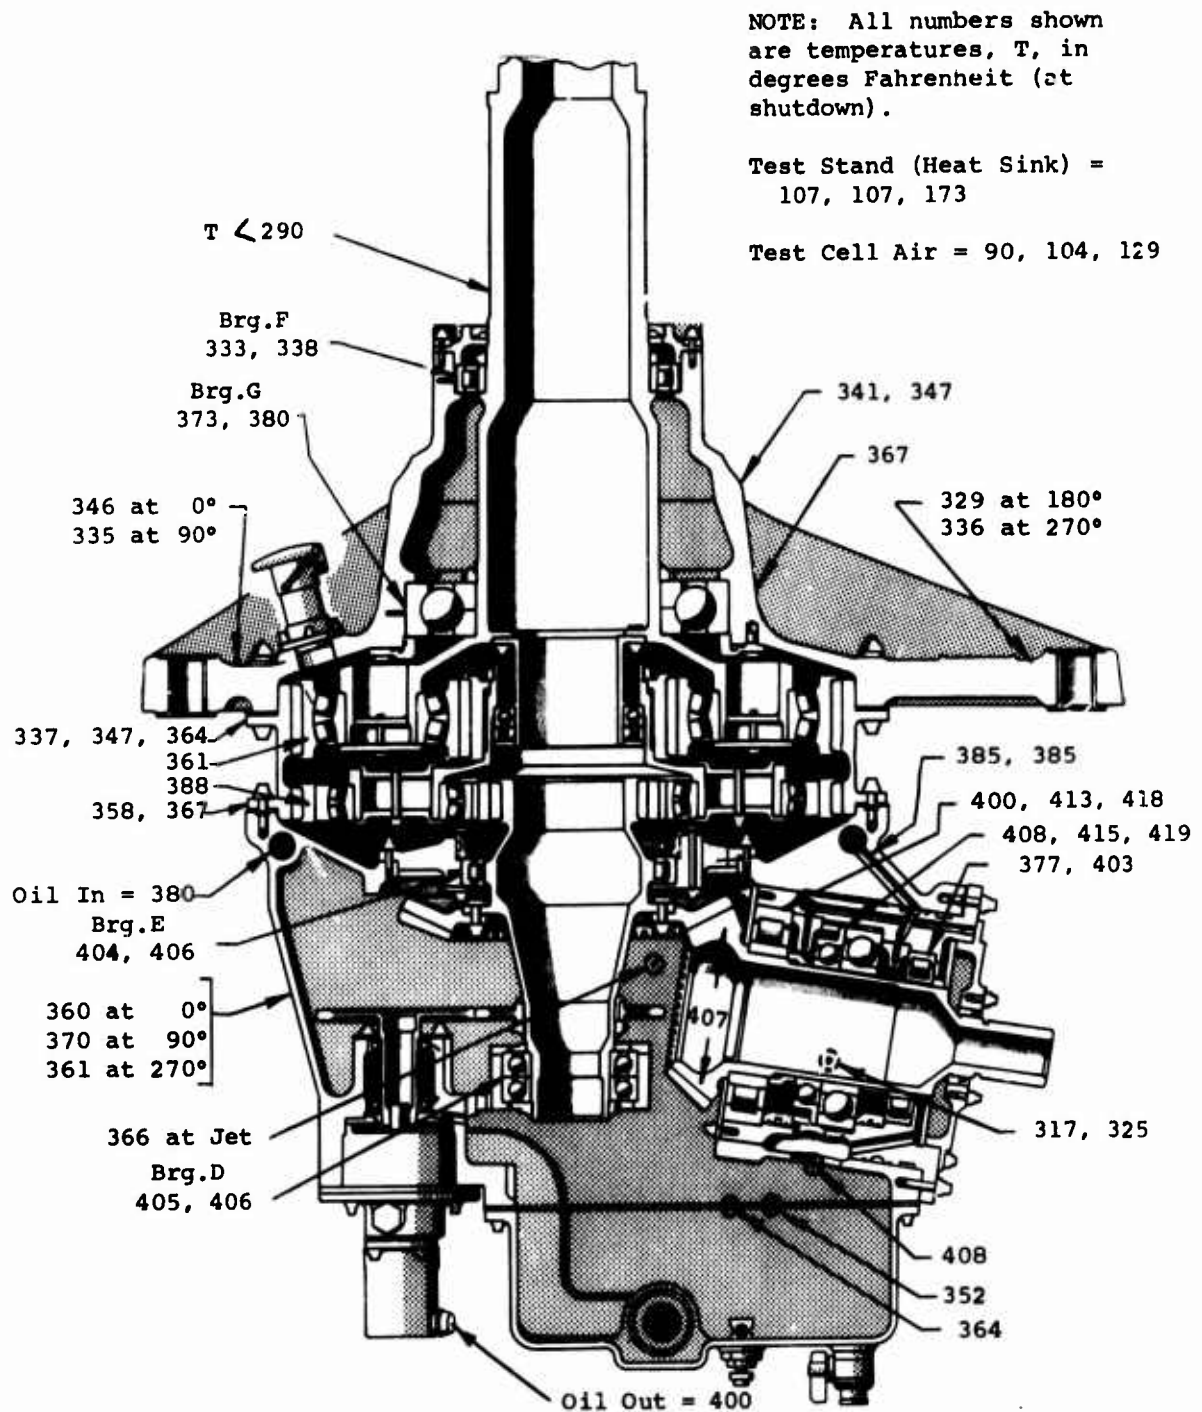
Figure 56. Thermal Map of Test 3 at 50 Percent Torque.

Figures 56, 57, and 58 are thermal maps indicating the component and/or case temperatures recorded in real-time and/or at shutdown. They represent the 50 percent, 75 percent, and 100 percent torque segments of test 3, respectively. As noted previously, the reader is referred to the section below entitled Data Reduction and Evaluation for a critique of this presented data.

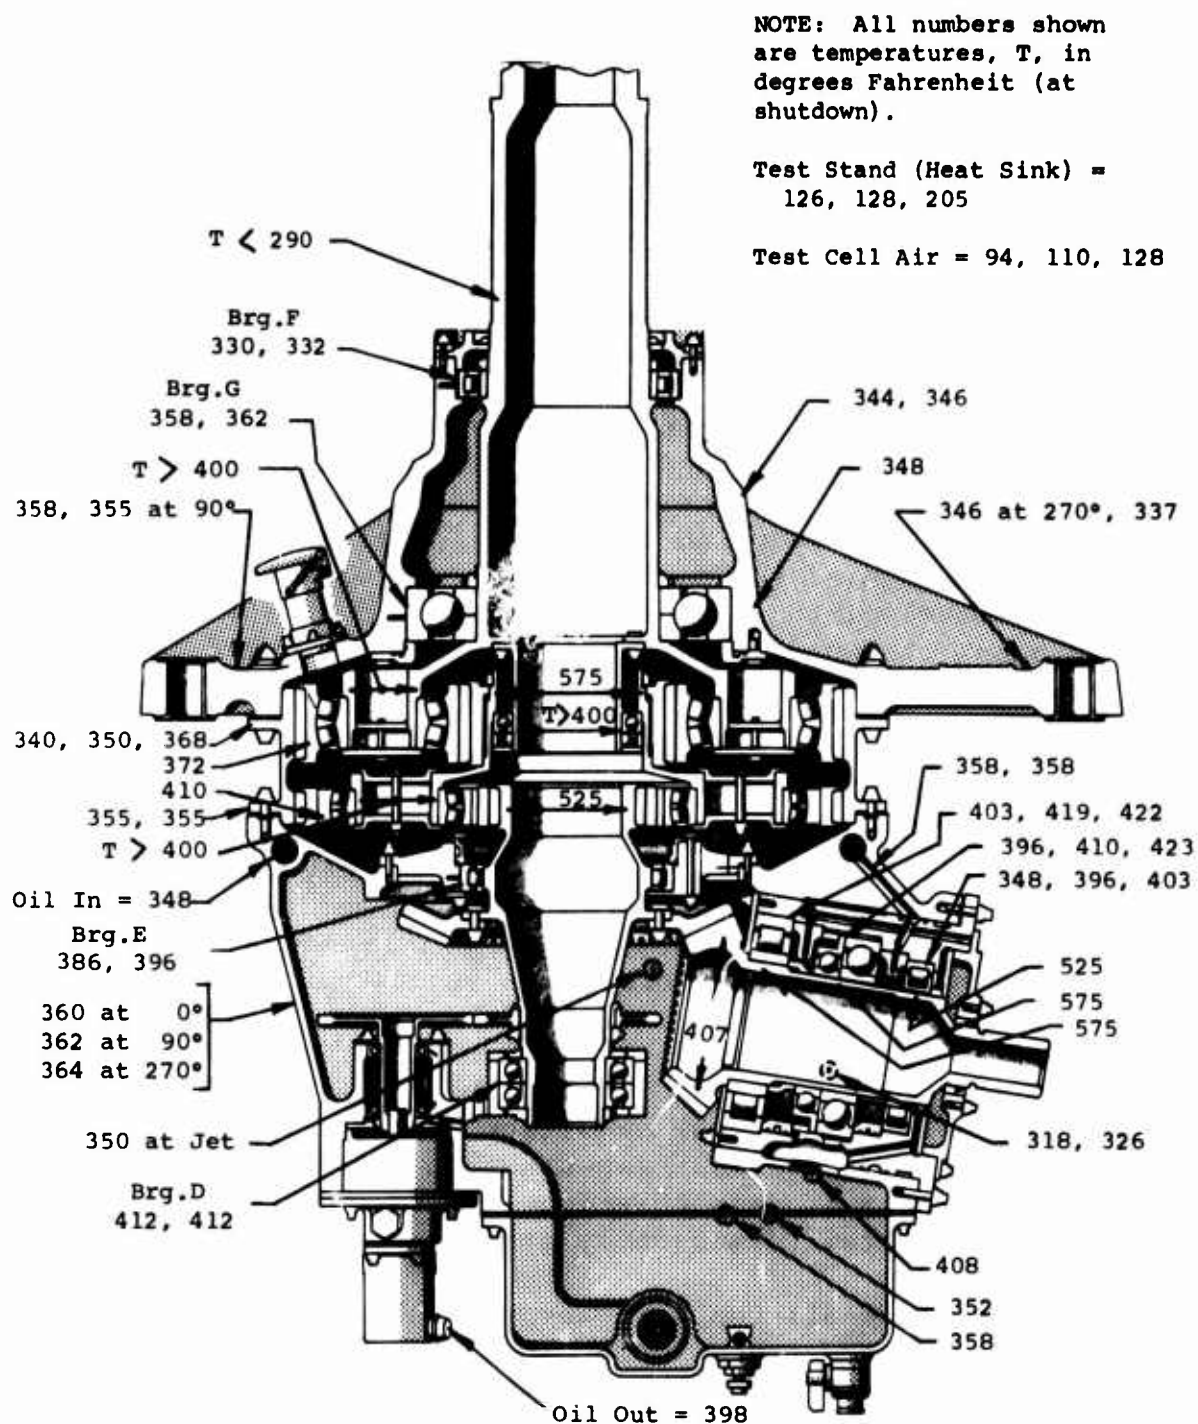
Figure 58. Thermal Map of Test 3 at 100 Percent Torque.

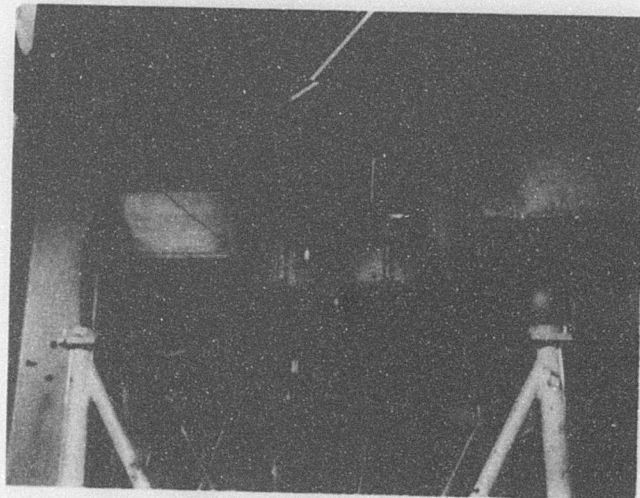
Figure 59. Specimen Transmission Disassembled for Inspection in Test Stand (End of Test 3 at 50 Percent Torque).

inspected at the end of that segment. Figure 59 shows the state of the disassembled specimen transmission in the test stand. Figure 60 shows the acceptable condition of the spiral bevel pinion. Figure 61 shows the condition of the sump, screen, and thermocouple. First- and second-stage planetary components were visually inspected in the test stand (by removing the quick-disconnect breather standpipe shown in position in Figure 59), but no photographs were taken.

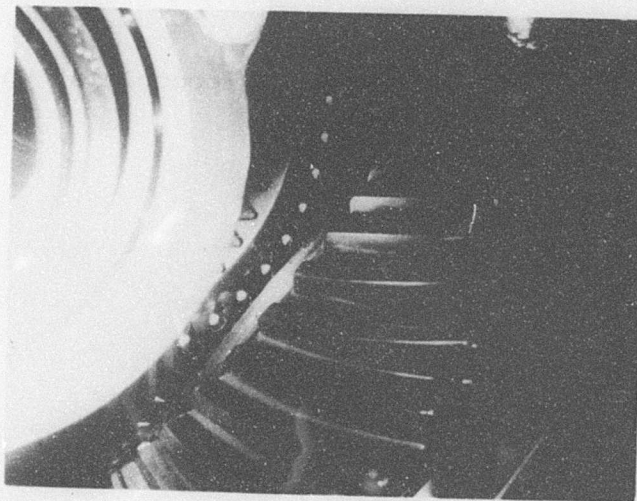
Figure 60. Spiral Bevel Pinion After Test 3 at 50 Percent Torque.

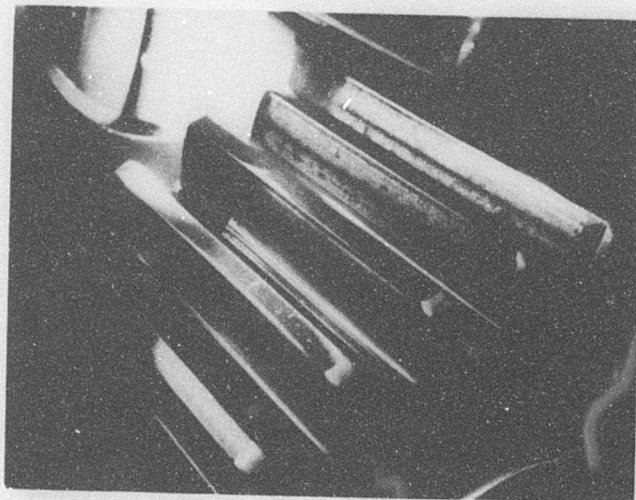
Figure 66. Second-Stage Planet Gear at End of Test 3 at 75 Percent Torque.

A teardown inspection (out of the test stand) was made after the 75 percent torque run segment of test 3. Figures 62 through 66 are photographs of the acceptable condition of the teeth of the spiral bevel pinion, first-stage sun, first-stage planet, second-stage sun, and second-stage planet gears, respectively. Figure 67 shows the condition of the sump, screen, and thermocouple. Figure 68 shows the installation of new thermoplacards behind the oil dam (dam removed) on the I.D. of the spiral bevel pinion at bearings A, B, and C. (The installation of a new thermoplacard on the conical I.D. under the spiral bevel pinion teeth is out of the photograph field of view.)

As may be seen, the teeth on the flank of the spiral bevel pinion were lightly frosted; classically light frosting was present on all other gears. In addition, three teeth on the first-stage sun gear were lightly pitted and may be seen in Figure 63. After the three pitted teeth on the first-stage sun gear were dressed, all components were deemed acceptable to undergo the 100 percent torque run segment of test 3.

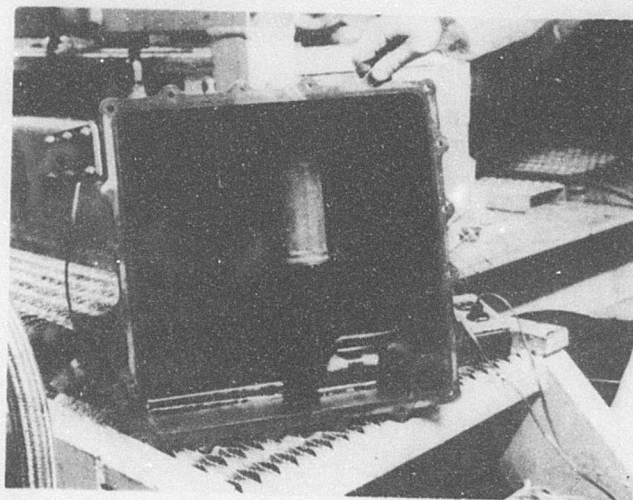
Figure 67. Sump, Screen, and Thermocouple at End of Test 3 at 75 Percent Torque.

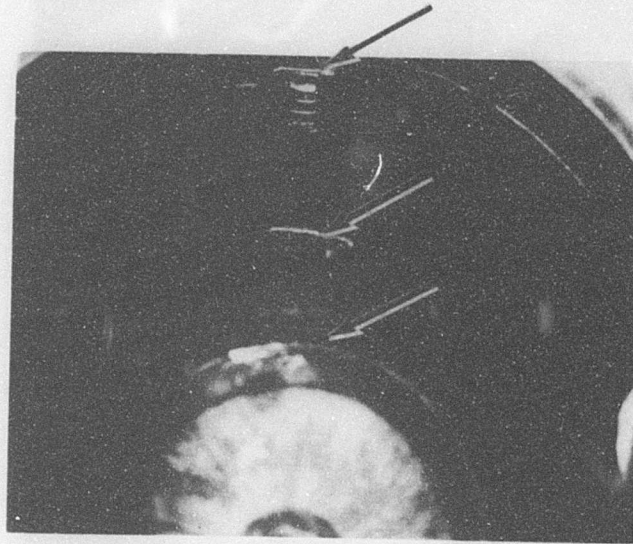
Figure 68. Installation of New Temperature Placard on Spiral Bevel Pinion.

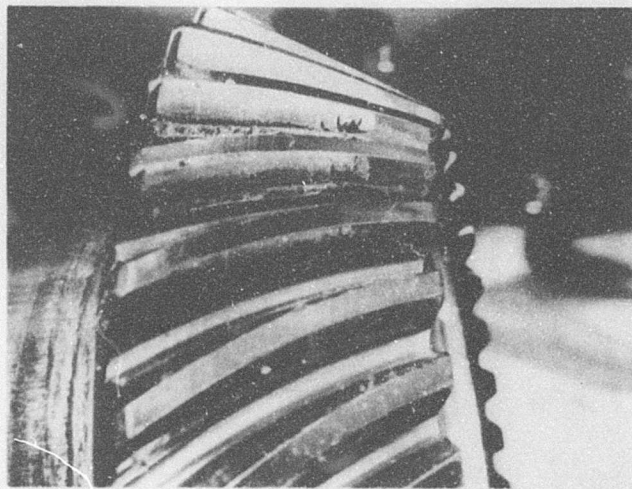
Figure 69. Final Condition of Spiral Bevel Pinion.

The final teardown inspection (out of the test stand) was made after the 100 percent torque run segment of test 3. Figures 69 through 73 show the final condition of the spiral bevel pinion, spiral bevel gear, first-stage sun, first-stage planet, and second-stage sun, respectively. Figure 74 displays all parts in their detail disassembly state.

All parts survived all tests; however, the spiral bevel gear set shows aggravated tooth surface distress (scoring and pitting). The first-stage sun also shows aggravated tooth surface distress (pitting); the first-stage planet shows light surface distress (pitting, and frosting progressing to light scoring). The second stage shows unprogressed light "classical" frosting. There were no irregularities in the bearings or other major components. The final inspection revealed that the specimen transmission may be used in further tests. It is known

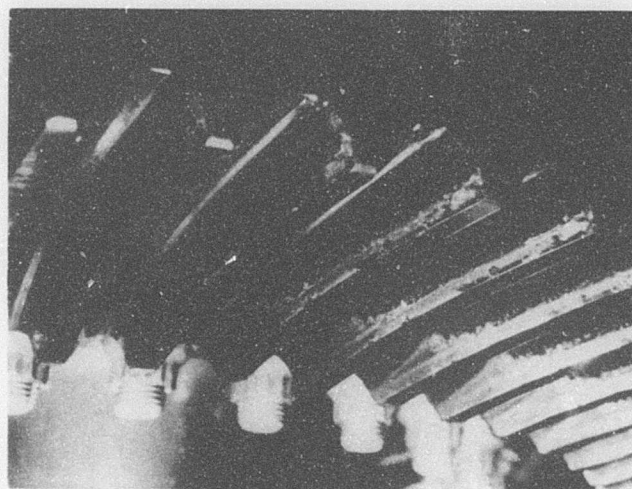
Figure 70. Final Condition of Spiral Bevel Gear.

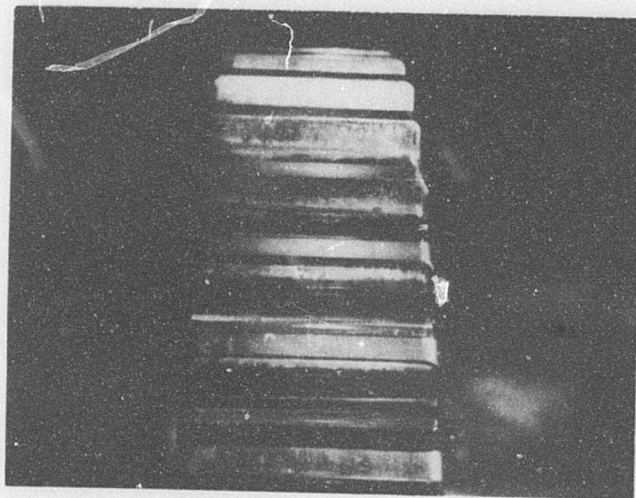
Figure 72. Final Condition of First-Stage Planet Gear.

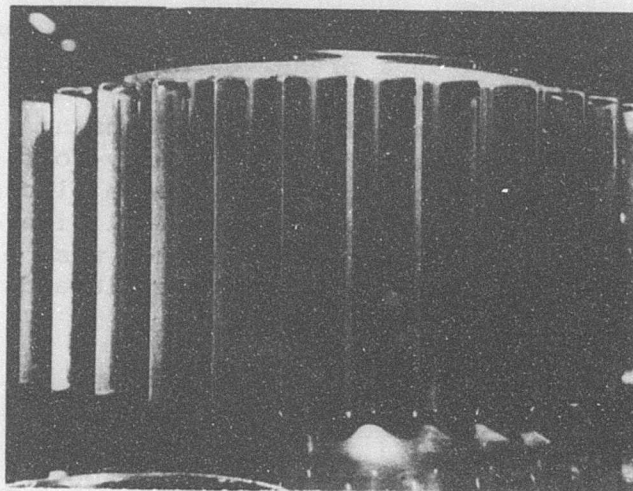
Figure 73. Final Condition of Second-Stage Sun Gear.

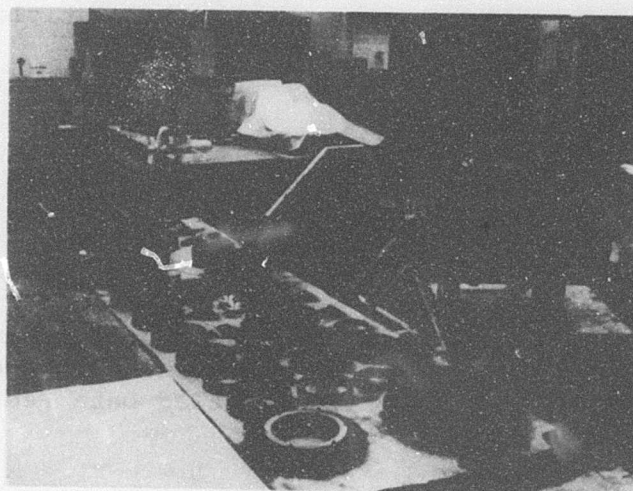
Figure 74. Thermal Mapping Test Specimen Parts in Detail Disassembly State.

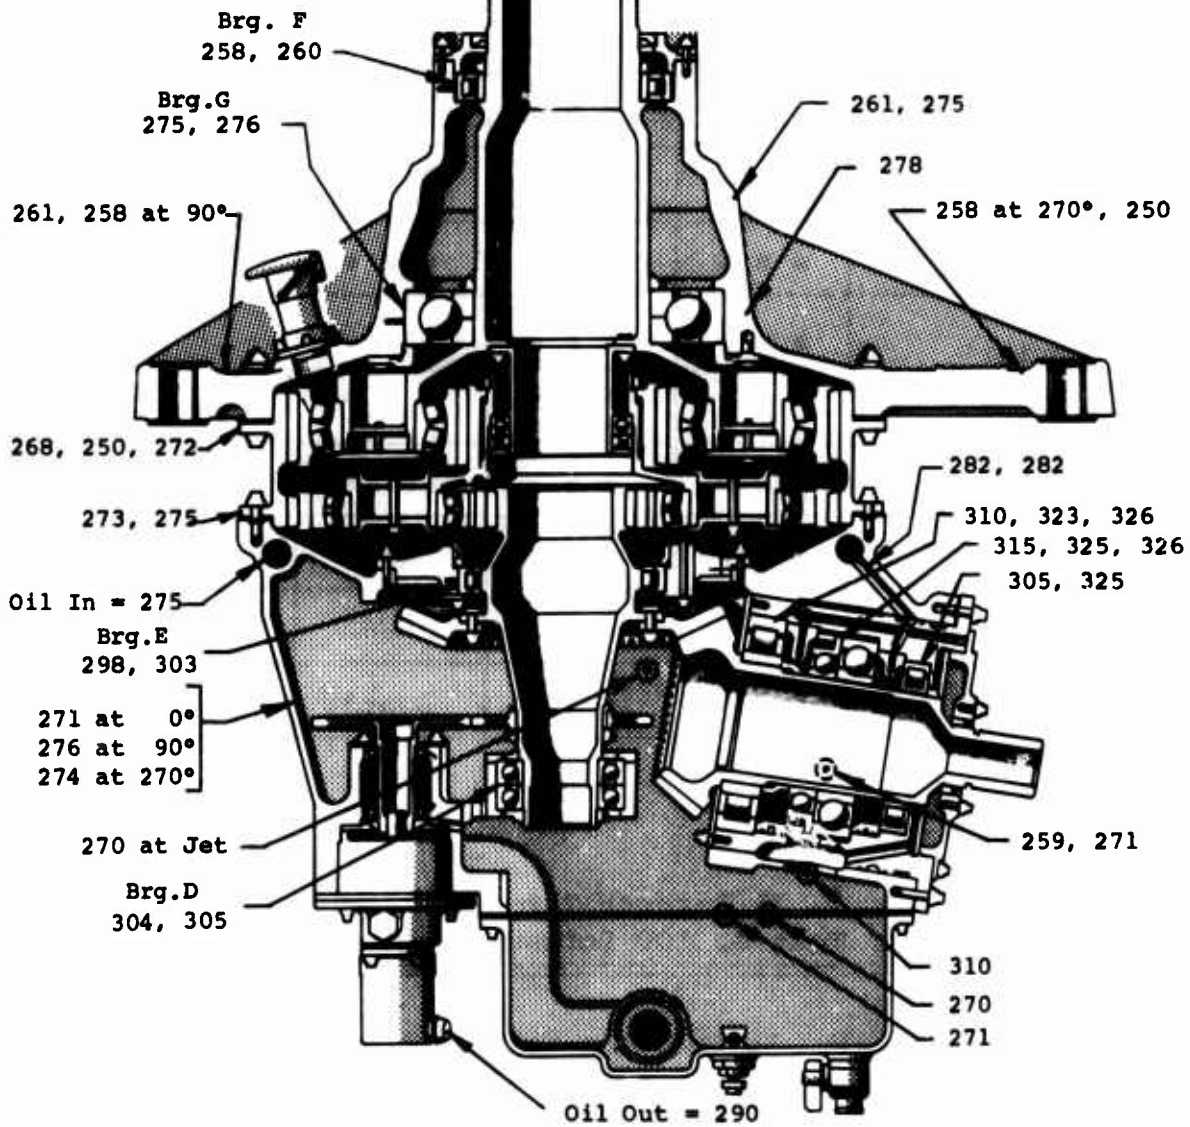
Figure 75. Thermal Map of Hunting/Search Torque (40 Percent Run at Oil-Out = 400°F ± 10 Percent.

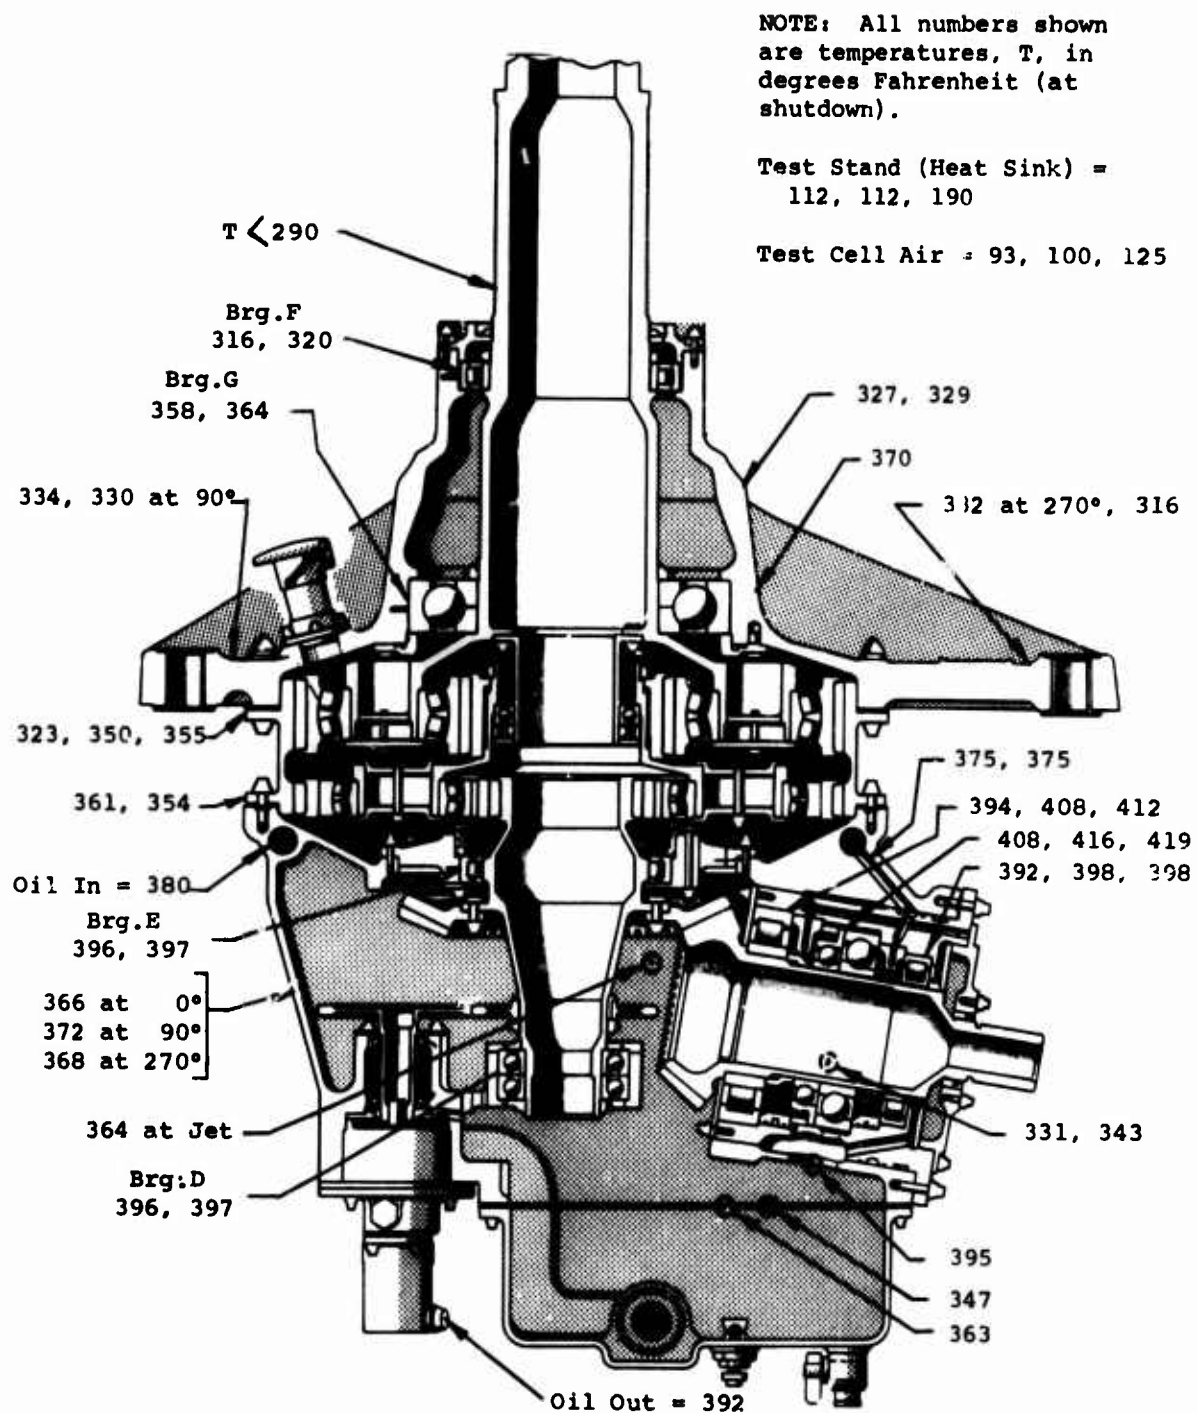
Figure 76. Thermal Map of Dimensional Growth Run.

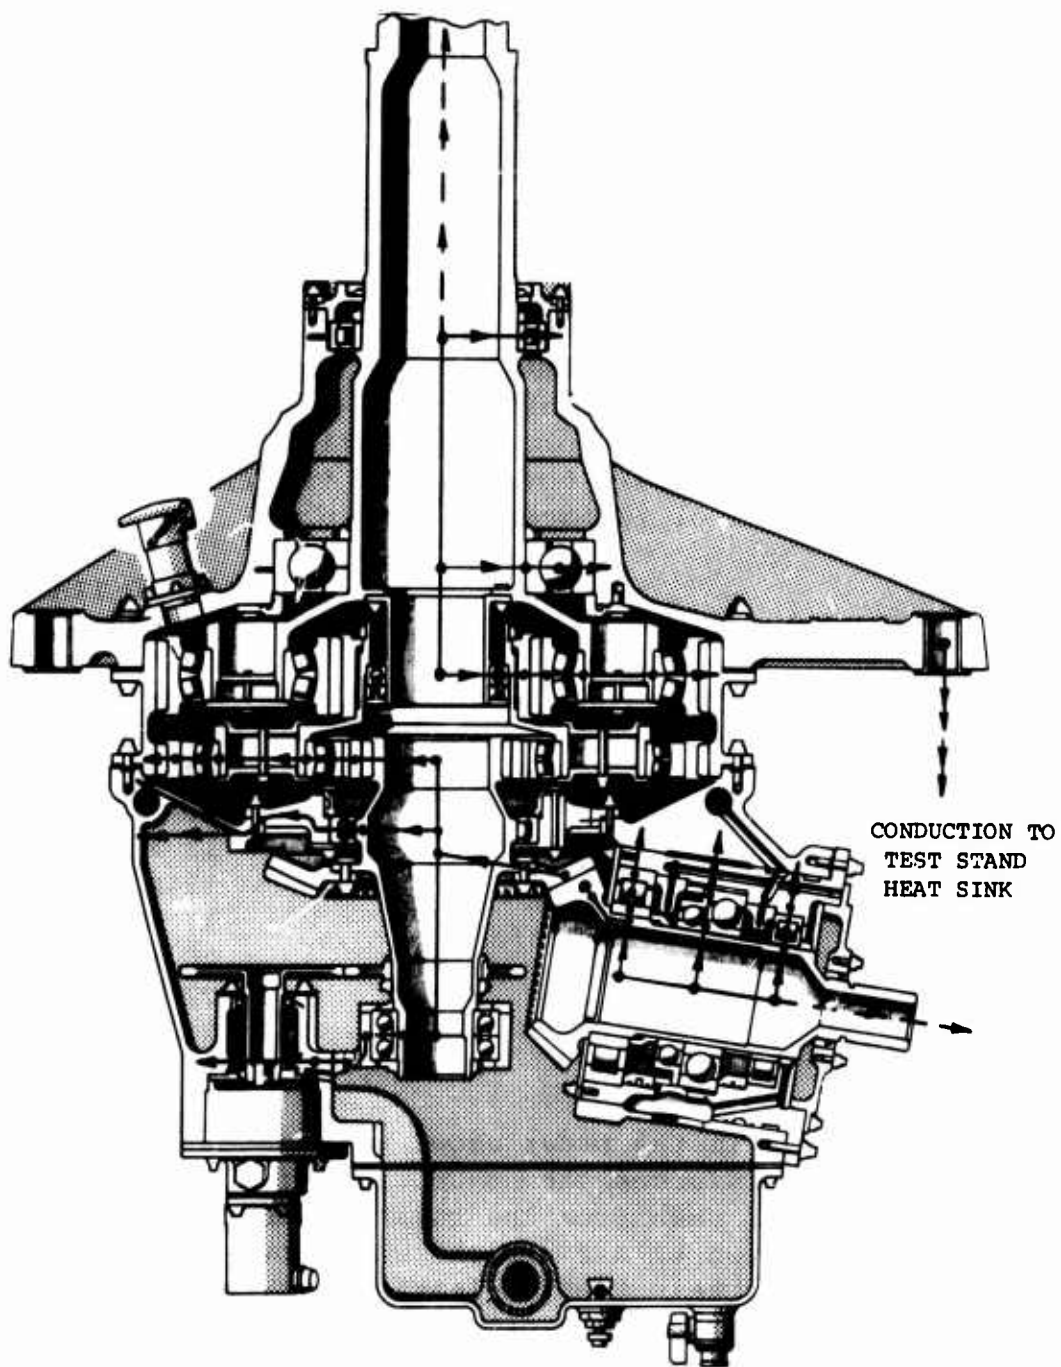
Figure 77. Illustration of Intern l Conductive Heat Paths of Specimen Transmission.
